Five-Year Review Report

Second Five-Year Review Report for Perham Arsenic Site Perham Otter Tail County, Minnesota

September 2006

Minnesota Pollution Control Agency
525 S. Lake Avenue, Suite 400
Duluth, Minnesota 55802

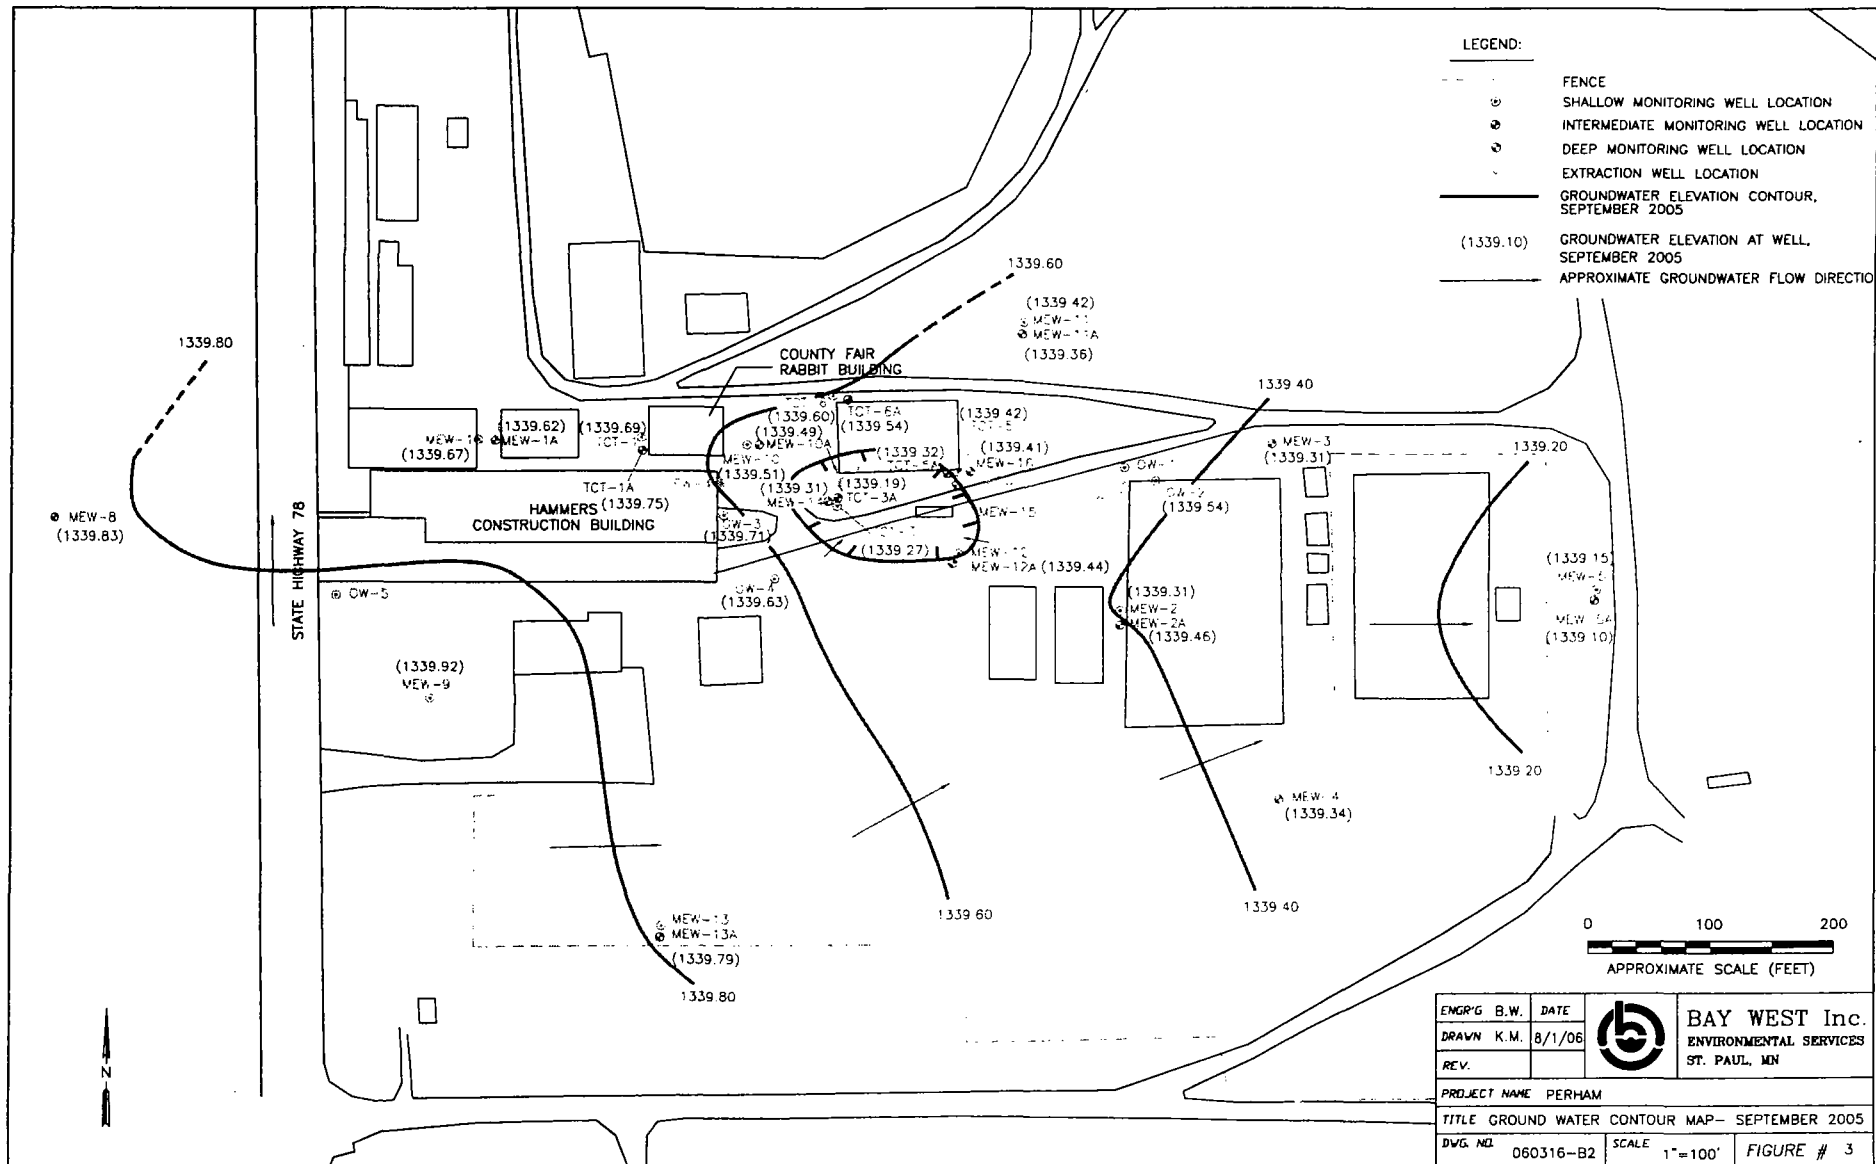
The topography around the Site is flat and gently slopes eastward toward the Otter Tail River, approximately 1.8 miles to the east. The Site surface consists largely of open, grassy fields and dirt roads. Several brick, wood and aluminum buildings exist on the Site (Figure 2). Subsurface features at the Site are characterized by a massive unit of glacial outwash sands and gravel. In the Perham vicinity, a confining clay unit is reported to exist within the glacial outwash. However, the confining clay unit was not encountered during RI activities performed at the Site. Ground water in the vicinity of the Site flows in an east to southeast direction towards Otter Tail River (Figure 3).

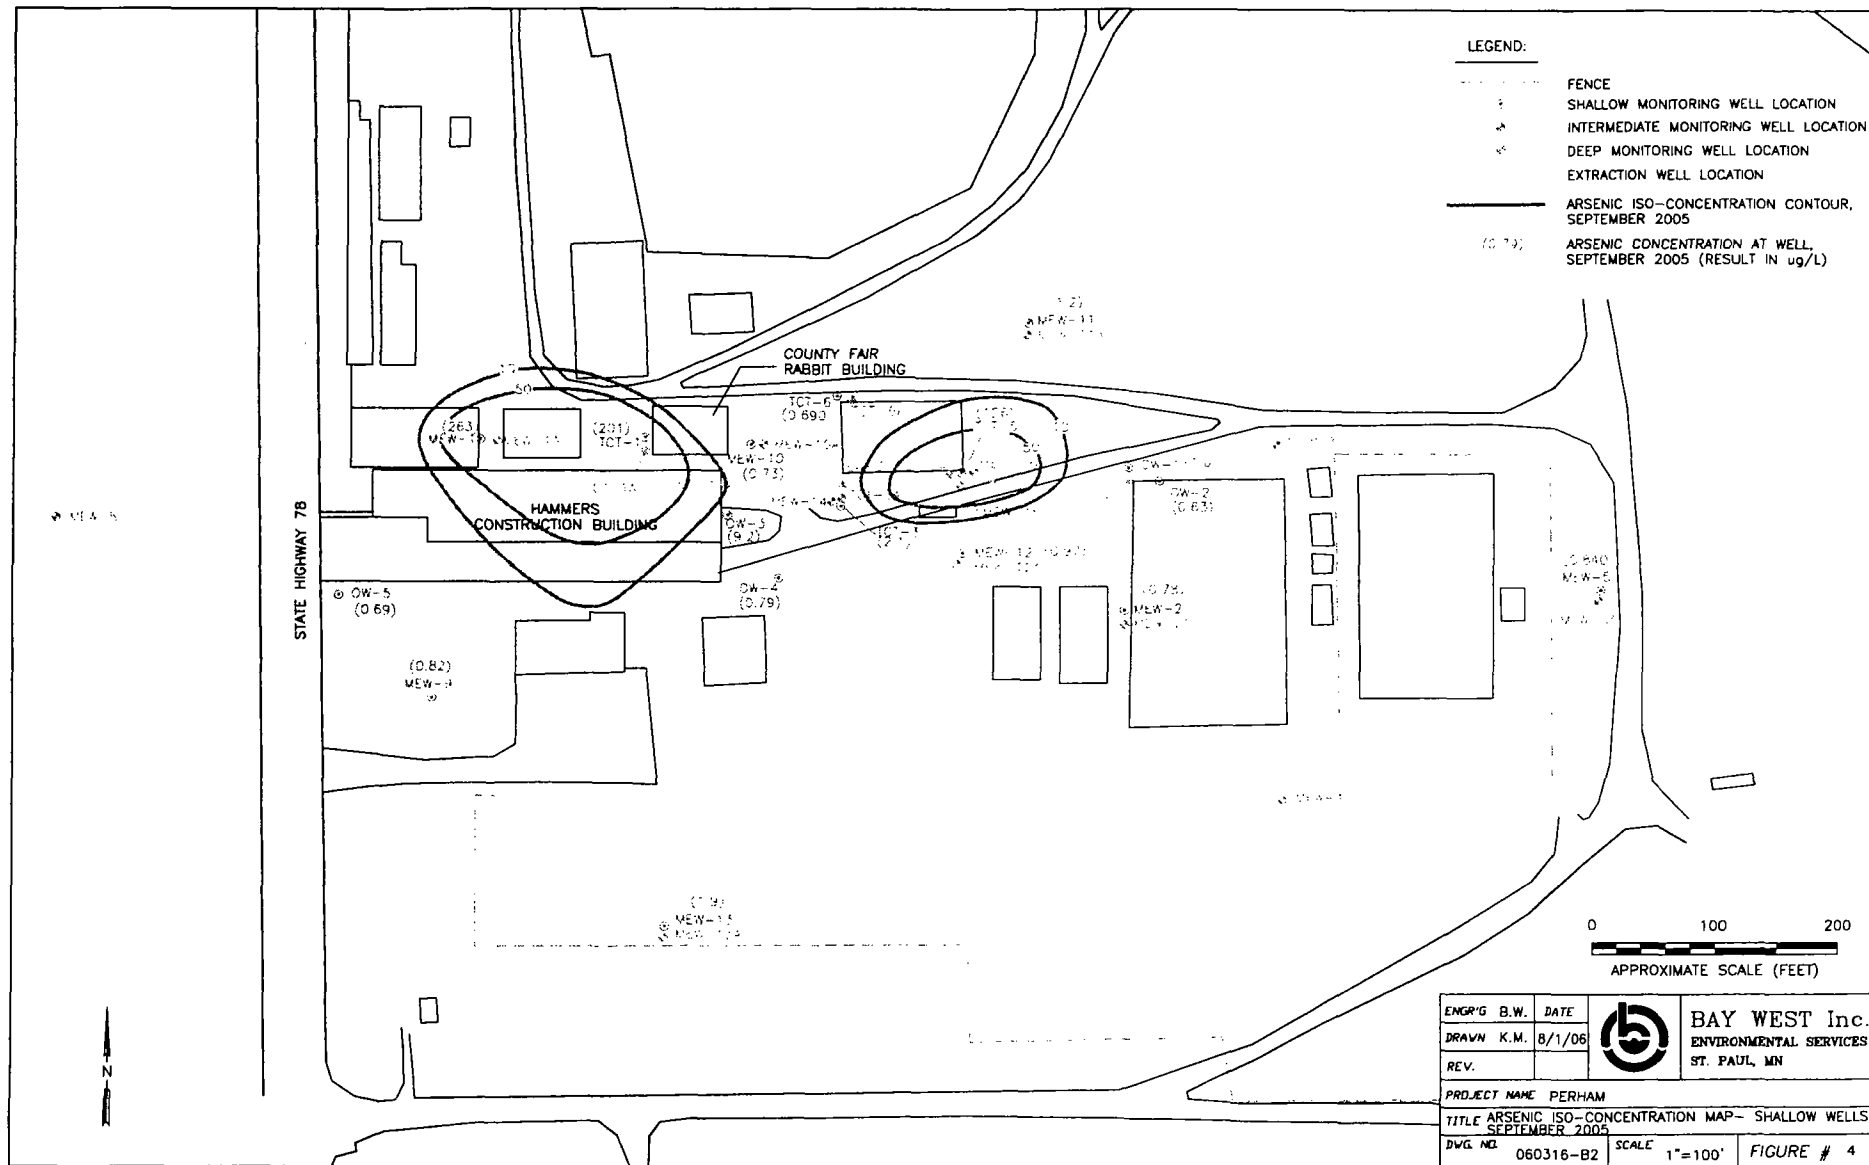
The September 2005 data was also used to develop arsenic iso-concentration maps, one shallow (Figure 4), and one intermediate (Figure 5.). Metcalf & Eddy's 1993 analysis of the Site data found that arsenic concentrations increased with depth in ground water as distance increased down-gradient (east) from the Site. Contaminant C concentrations in the aquifer have decreased since the 1993 evaluation and are at lower concentrations at depth when compared to the shallow wells.

In summary, the ground water contamination plume is being contained by the extraction wells and significant reduction in arsenic concentrations has been observed at the outer edges of the plume. The September 2005 analytical results show that arsenic levels in the intermediate wells have generally decreased but some wells have concentrations that are as high as 150 $\mu\text{g/L}$ (TCT-1A).
